# Operation TEAPOT

## NEVADA TEST SITE

Project 5.4

EVALUATION OF FIREBALL LETHALITY USING BASIC MISSILE STRUCTURES (C)

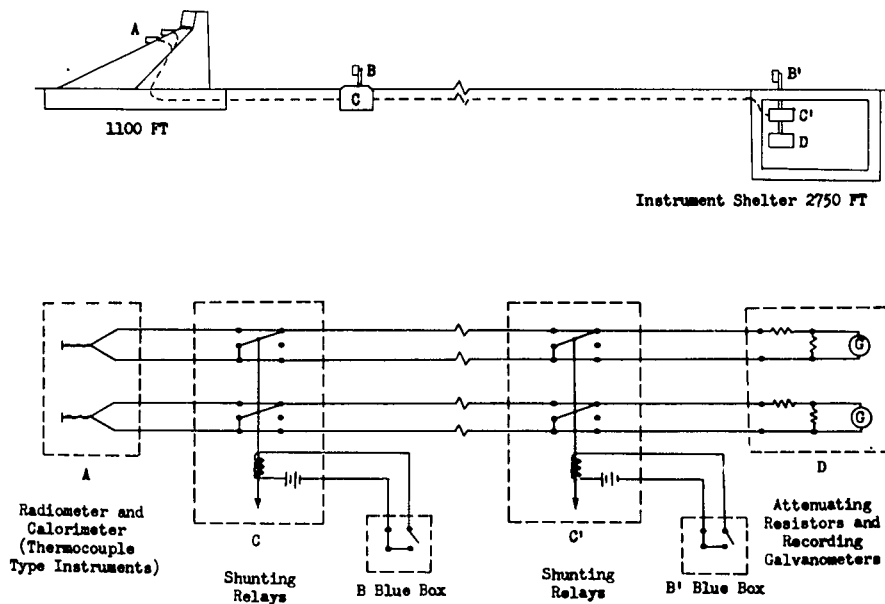
Figure 2.13 Instrumentation Schematic

type calorimeter, and one thermal-energy-intensity measurement, made with a foil radiometer. These instruments were similar to the standard type made by the Naval Radiological Defense Laboratory (NRDL). The basic function of these instruments is measuring, by means of a thermocouple, the temperature rise of a metal disk in the calorimeters, and of a foil in the radiometer. Descriptions of these standard instruments may be

found in "The Thermal Data Handbook" (AFSWP 700). Two of the standard type instruments were especially modified and calibrated by NRDL to measure the required thermal inputs.

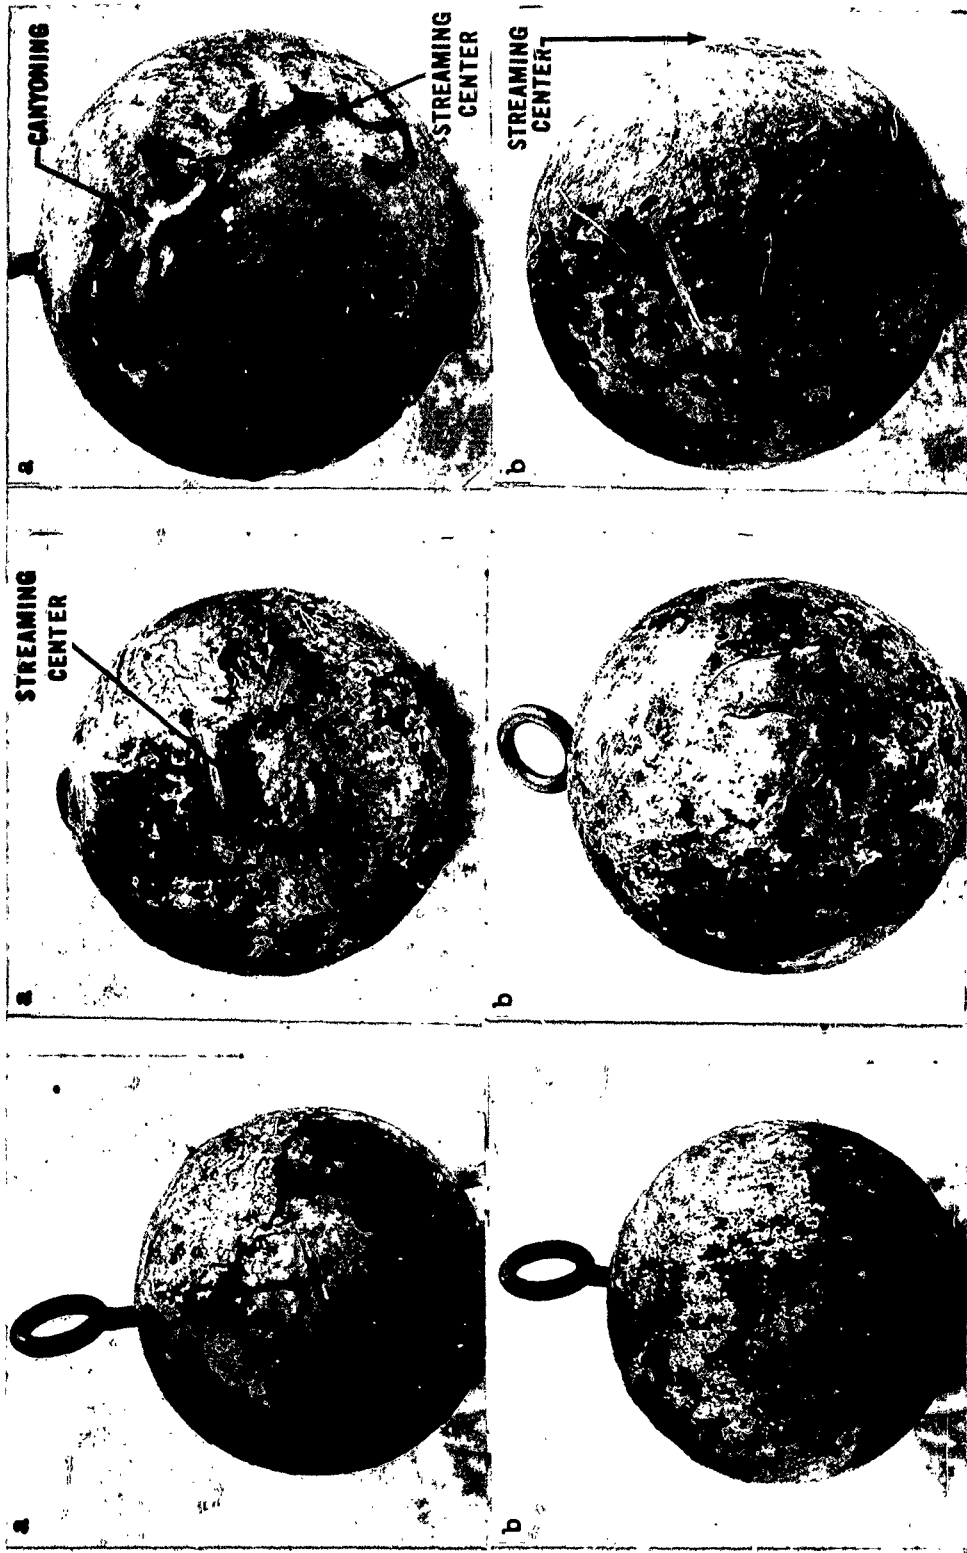
**Figure A.7** Aluminum Sphere, Tower 2. (a) Showing Extreme Molten Metal Runs; (b) Side Opposite Metal Runs.

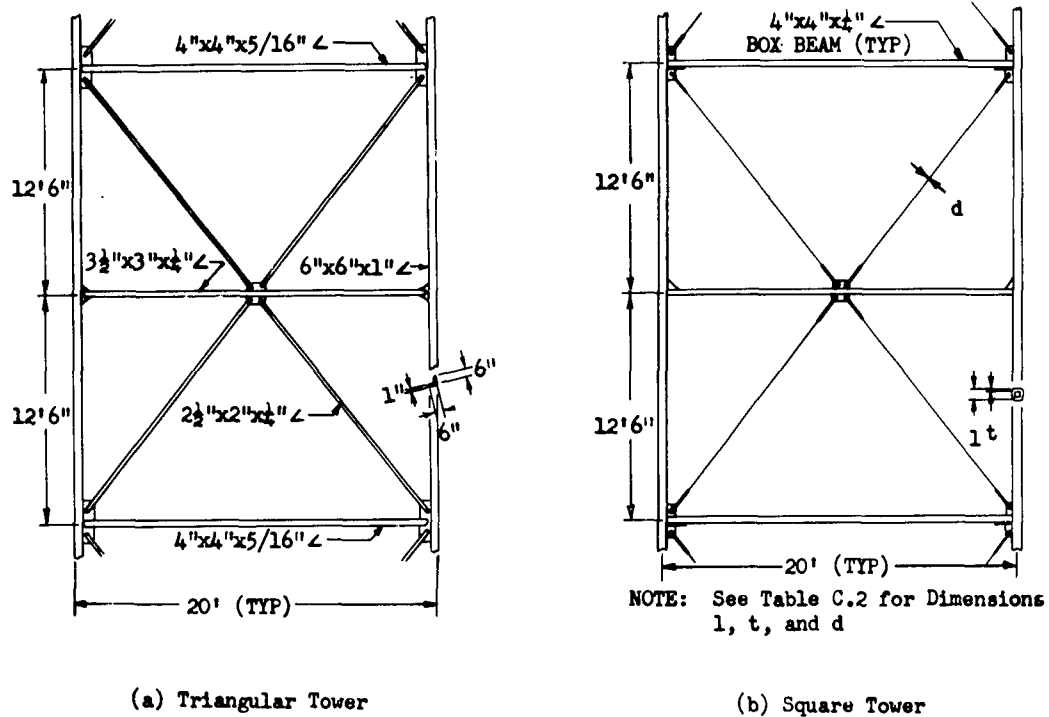
Figure C.1 Typical Tower Construction
